## Make Sure That Stove Doesn't Tip!

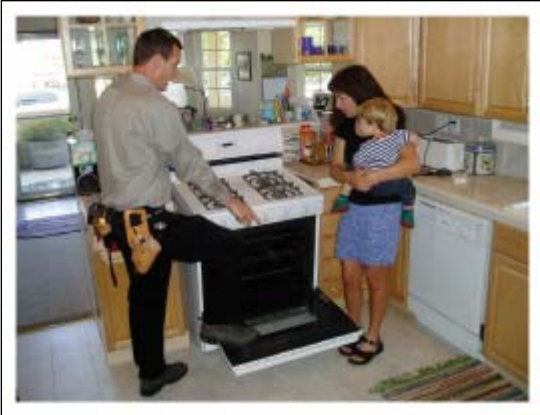
The proper installation of a stove requires the attachment of an anti-tip device. These devices are included with all new stoves, but often are not installed.

An anti-tip bracket is generally attached to the bottom of the wall behind the stove, and clips to the rear legs. This allows the stove to be moved for cleaning and maintenance. If you do not have the original bracket which was supplied with the stove, brackets can be purchased at any home center or appliance store.

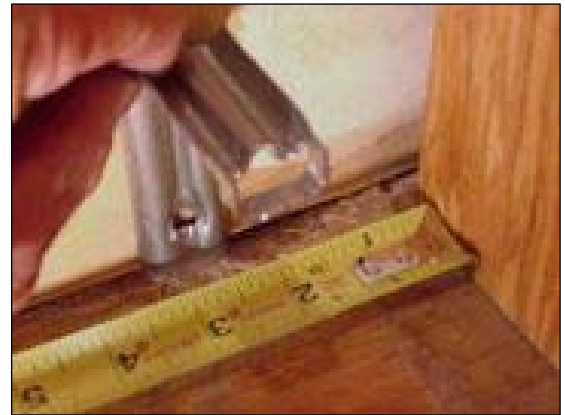
Stove tip-overs frequently occur. If a child steps on an open oven door, or a heavy pot is placed on an open door, the door acts as a lever and forces the stove to tip.
